23rd International Lightning Detection Conference
18 - 19 March • Tucson, Arizona, USA
5th International Lightning Meteorology Conference
20 - 21 March • Tucson, Arizona, USA

Overview of the Kansas Windfarm2013 Field Program

Kenneth L. Cummins and Mason G. Quick
Department of Atmospheric Sciences
University of Arizona
Tucson, Arizona, USA

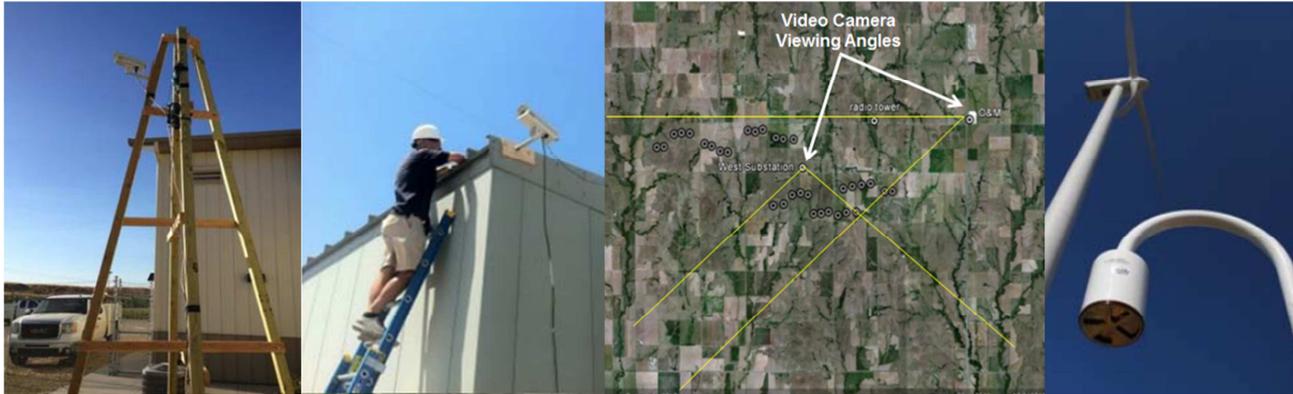
Fig. 2. (From Left to Right) Video camera installation at the Operations & Maintenance Building; video camera installation at the sub-station; map of the video camera viewing angles; view of an electric field mill installed at the wind farm

Observations for the 2012 campaign included standard-speed video observations from two cameras, static electric field using two electric field mills, NLDN observations of cloud-to-ground (CG) return strokes, and *in-situ* current transient measurements in all turbine blades reported by the “Supervisory Control and Data Acquisition” (SCADA) system. The two digital video camera systems (60 fields-per-second) were configured to self-trigger 2-second video sequences using a sequential-field-subtraction scene analysis (ufo-Capture). The two cameras had a small common field of view that included 8 of the wind turbines. Nearby NLDN sensors were configured to record information that allows reconstruction of magnetic field waveforms within the bandwidth of the NLDN sensors. The on-site instrumentation is shown in Figure 2.

The electric field mills (EFMs) and standard-speed automatic cameras were the same ones that were used in 2012, as shown in Fig. 2. The EFM locations where changed in 2013, indicated by arrows in Fig. 3. The NLDN observations included both cloud and cloud-to-ground discharges, as well as continuous waveform data. In addition, all turbine generators were equipped with devices that provide estimates of lightning peak current within the blades, as was the case in 2012.

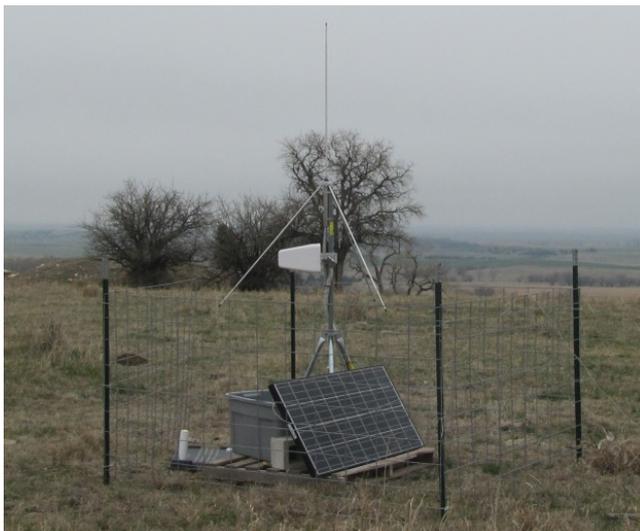
Fig. 4. Portable Lightning Mapping Array (LMA) Station.

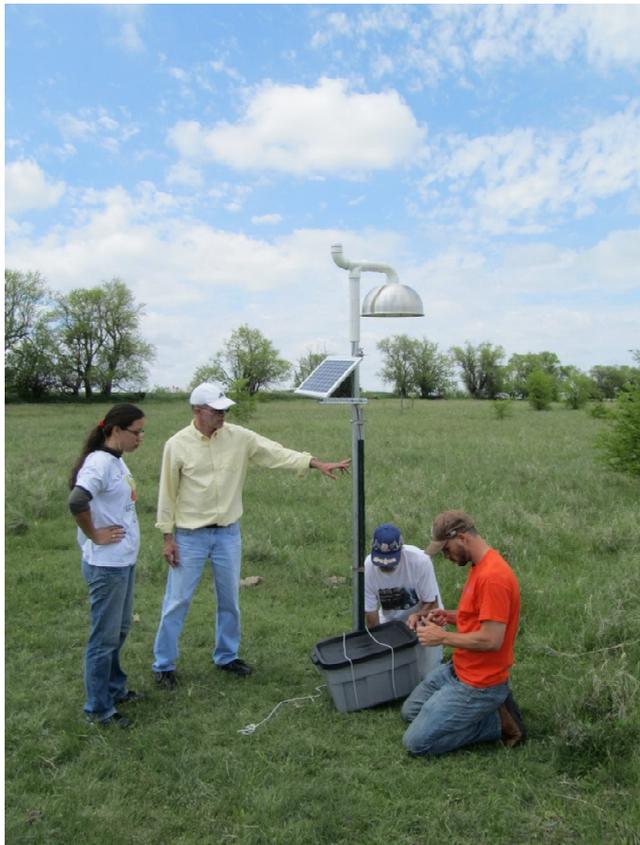
Fig. 6. New Mexico Tech solar-powered slow antenna installation. Battery box is being installed by Ron Thomas and Mason Quick, while being well-managed by our illustrious Brazilian team.

The 8-station slow antenna network provided information about the times, locations, polarity, and magnitudes of lightning processes associated with significant charge transfer. The slow antenna sensors, designed by New Mexico Tech, had a low-frequency time constant of 10 seconds, and an upper frequency response of 25 kHz. The data were sampled at a 50 kHz rate. The nominal sensitivity of the sensors allowed them to accurately measure field changes in the range of 10 mV/m to 10 kV/m. Fig. 6 shows one of these slow antennas as installed in Kansas.
